EASY BLUE WATER SAVINGS PROGRAM

Water Audit and Water Savings Action Plan: Wangaratta Livestock Exchange

December 2011

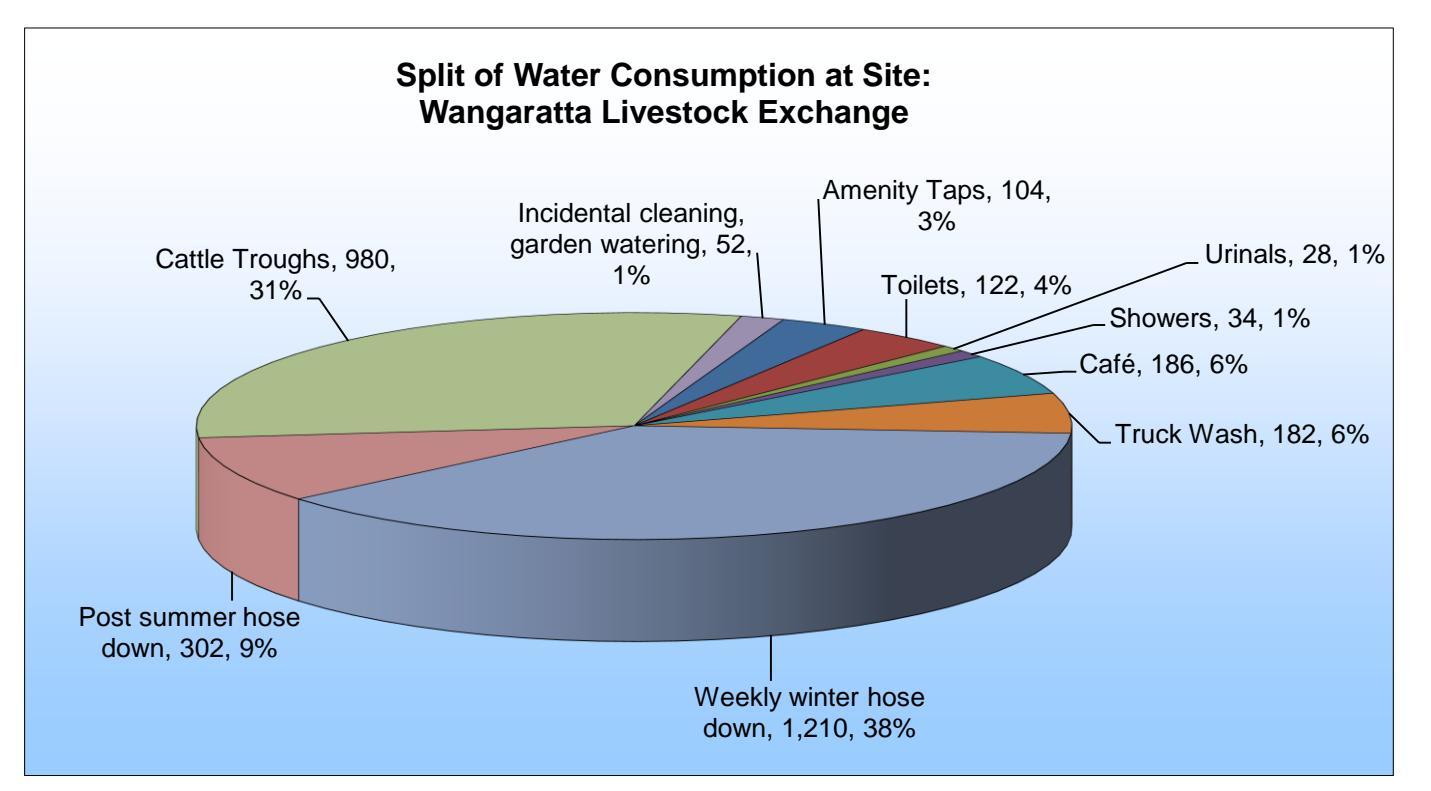
Figure 1: Water Balance for the Wangaratta Livestock Exchange (in kL and % of total)

As Figure 1 shows, the major water consumers at the site are the hosedowns in the saleyards (38%), and the cattle troughs (31%).

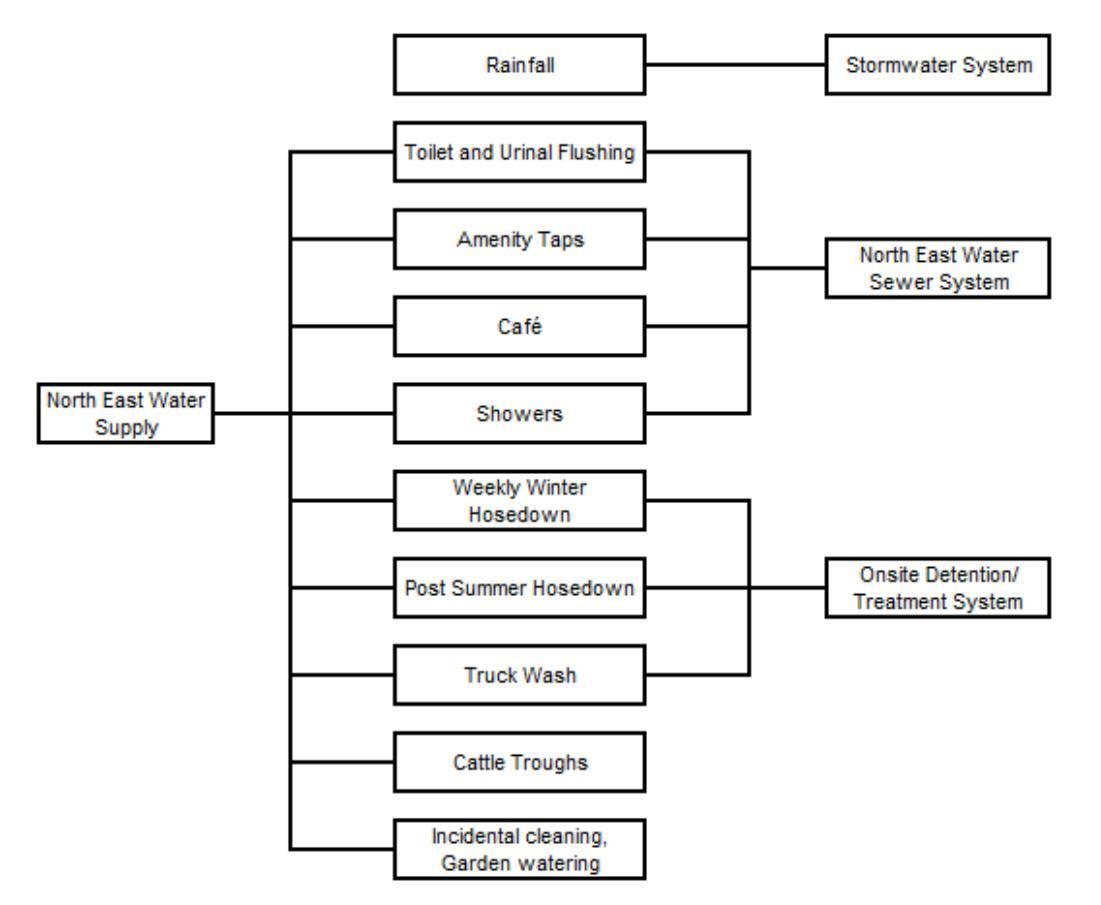
Figure 2: Single Line Diagram for the Wangaratta Livestock Exchange

The following single line diagram describes how water is supplied to, is used within, and is disposed from the site:

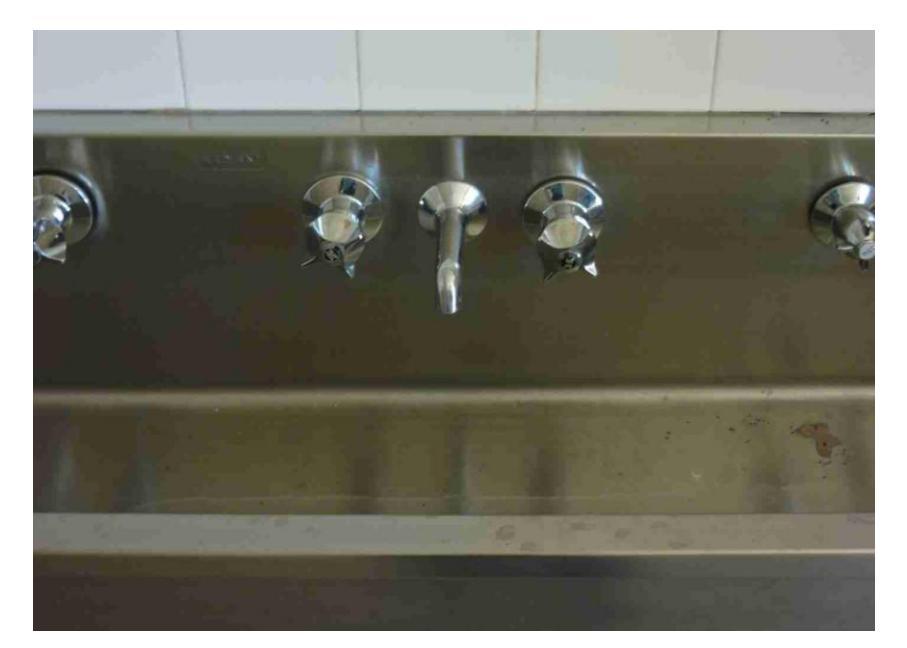
Figure 3: Example of an Amenity Tap at the Wangaratta Livestock Exchange

There is a set of amenities located adjacent to the site's café area. These are quite heavily used, since approximately 300 individuals use the site for an extended period of time on sale days - the vast majority eating onsite also. These taps have a very high flow rate at around 14L/min. The Water Efficiency and Labelling Standards Scheme (WELS), operated by the Australian Government provides an independent source of information about the water efficiency of devices such as showerheads, toilets, urinals, taps and dishwashers. The WELS scheme states that a flow rate of 4L/min is sufficient for amenity use.

The installation of in-line flow restrictors could bring the flow rates down with no loss of effectiveness. End of spout aerator style restrictors cannot be fitted to the site's tapware. A total of eight amenity basins at the site (four in the male; four in the female bathrooms) require flow restriction. Unfortunately, due to the nature of the basin troughs installed, it will be a more complex and expensive installation process than simply fitting a restrictor, since the trough itself will have to be removed to access the pipework behind it.

- Install in-line flow restrictors for the site's amenity hand basin taps
- Replace showerheads with low flow models

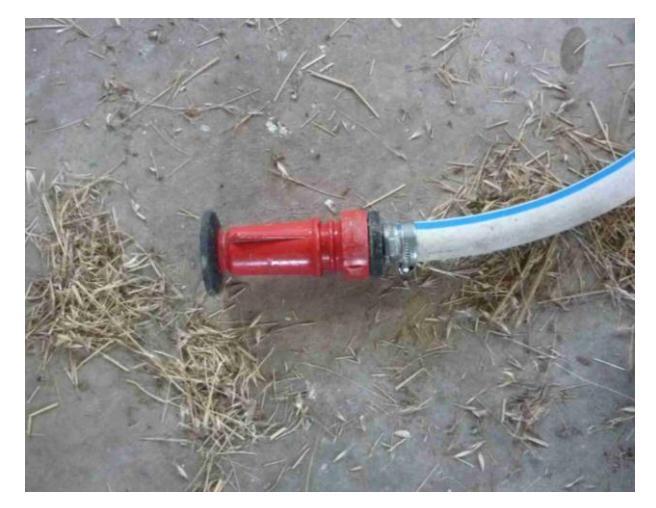
Figure 4: Hosedown Nozzle at the Wangaratta Livestock Exchange

The equipment used to hose down the pens was examined during the site visit. It was found to be of an excellent level of water efficiency, using pressure nozzles with adjustable flows and providing the ability to turn off flows at the nozzle saving potentially wasted water.

It therefore seems that the most viable means of saving hosedown water is to install roofing over the whole site. This would mean that woodchips can be used throughout the year, since they would not get too wet in winter. Such roofing has a number of significant benefits, namely:

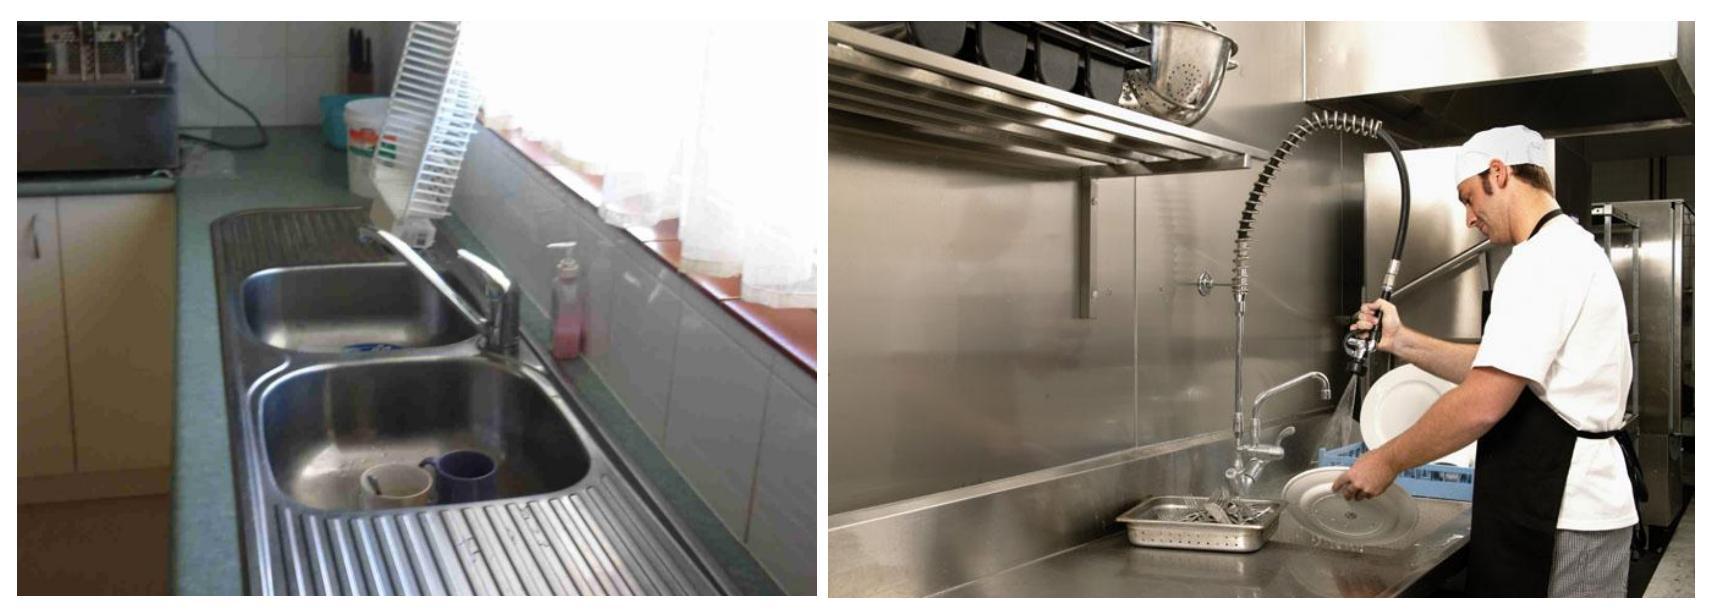
Figure 5. Washing Up Station at the Wangaratta Livestock Exchange (left) Figure 6: Pre Rinse Spray Nozzle in Use (right)

Water savings can be achieved in the site's kitchen with the installation of a pre-rinse spray nozzle into its washing up station. The site's washing up station is shown in Figure 5, and an image of a pre-rinse spray nozzle is shown in Figure 6.

These nozzles are used in commercial kitchens across Australia. Users often report that in addition to delivering water savings, they are quicker and easier to use than standard tapware.

- Install a pre-rinse spray nozzle into the Kitchen washing up station
- Install rainwater harvesting to feed cattle troughs
- Proceed with the plan to install roofing over the entire site

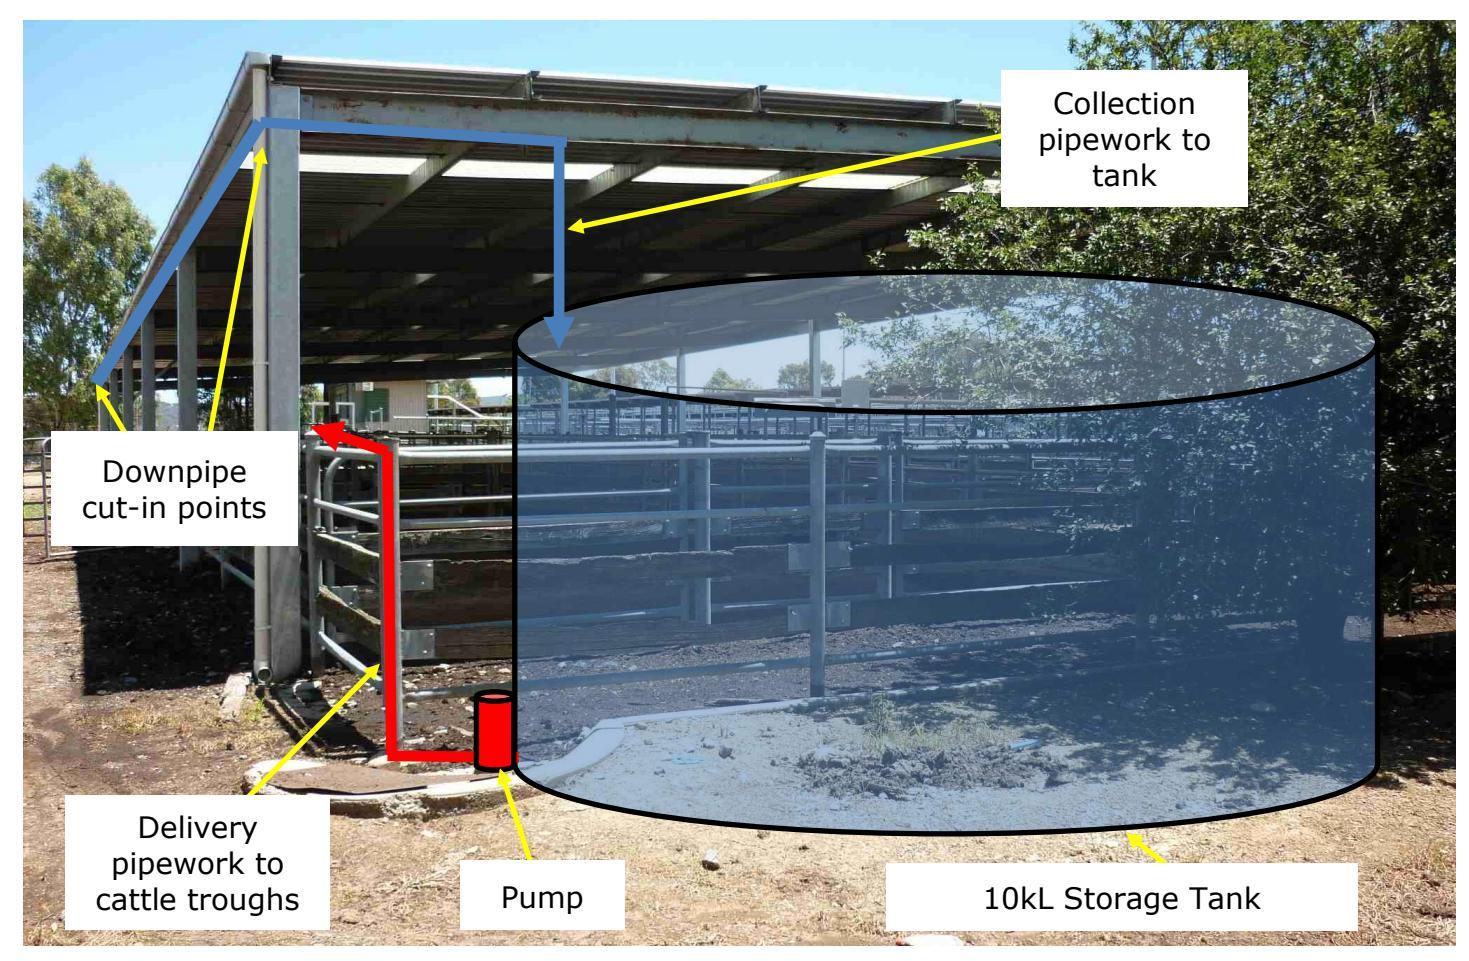
Figure 7: Possible Rainwater Harvesting Layout at the Wangaratta Livestock Exchange

The installation of a rainwater harvesting and reuse system using a small existing roof area is also a possibility for the site. A representation of the recommended rainwater harvesting system for the site is show in Figure 7:

Two downpipe cut-ins would be required for the system, with the tank located adjacent to the site's small roofed cattle pens. Overflows from the tank would be directed back into the existing stormwater system, located nearby. A standard pump would be used to supply the network of cattle trough filling pipework in the pens. An automatic changeover switch (for example, a Rainbank) would be used to ensure that potable water was always available as a backup when the rainwater tank is empty.

WaterGroup's rainwater harvesting modelling indicates that this system could save 135kL/year of water (see appendix for modelling outputs).

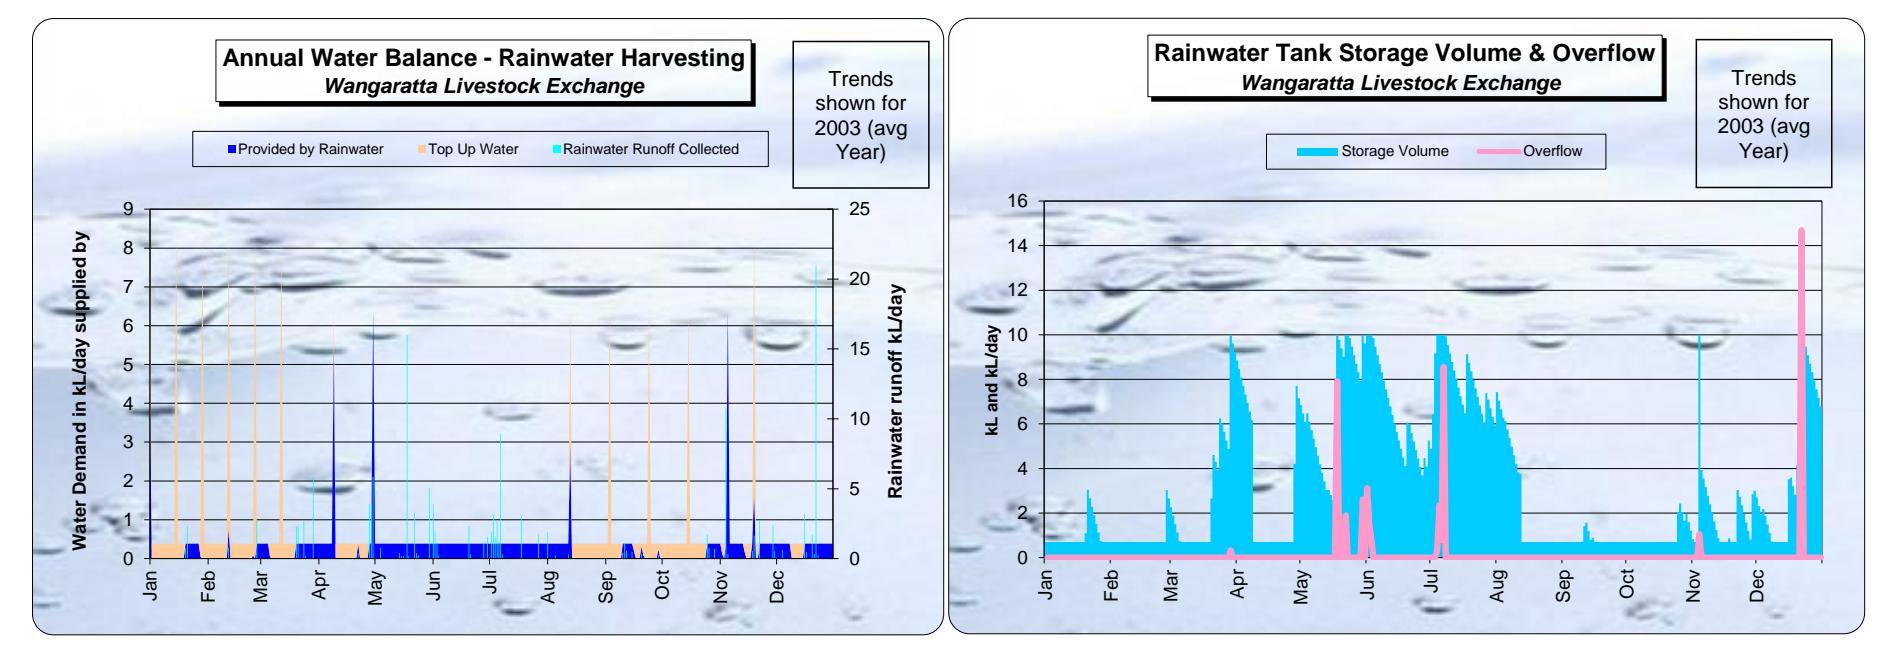
Model Input		Comments	Model Output - average for 1988 to 2007		Comments
Reference rainfall station	Wangaratta	avg annual rainfall: 625mm	Avg Available rainwater kL/yr	224	94% of demand
Rainfall collection area m2	432	1988 to 2007	Avg Water demand kL/yr	238	
Runoff coefficient	0.9	Roof Surface	Avg Overflow volume kL/yr	89	
Initial loss mm	1		Avg Top up water kL/yr	101	
Price of Water \$/kL	\$2.20		Avg Potable water savings kL/yr	135	
Rainwater used for	Cattle Trough	S	Avg % Potable water saved	58%	
Typical consumption & pattern	980kL/year		Avg % Available rainwater utilised	63%	
Tank Size kL	10	23 mm of rain to fill empty tank	Avg Cost Savings \$/yr	\$297
